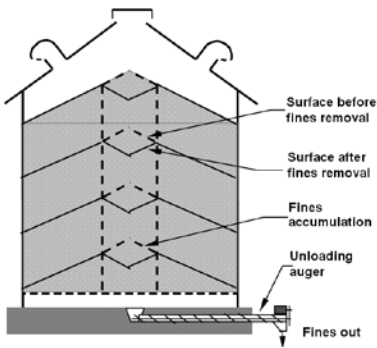
Figure 2.1 Removal of accumulated fines during bin filling.

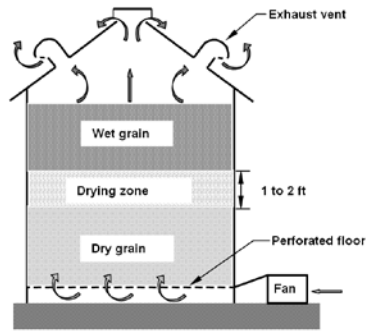
Figure 2.2 Illustration of a natural-air drying bin.

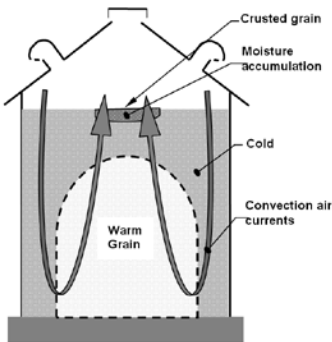
Figure 2.3 Moisture migration in grain that has not been adequately cooled.

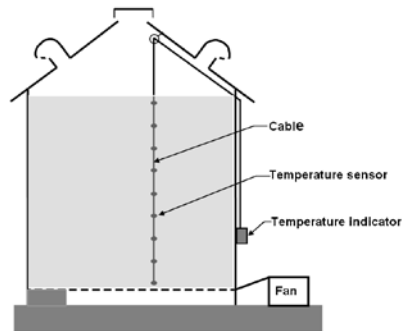
Figure 2.4 Permanently installed grain temperature cables.

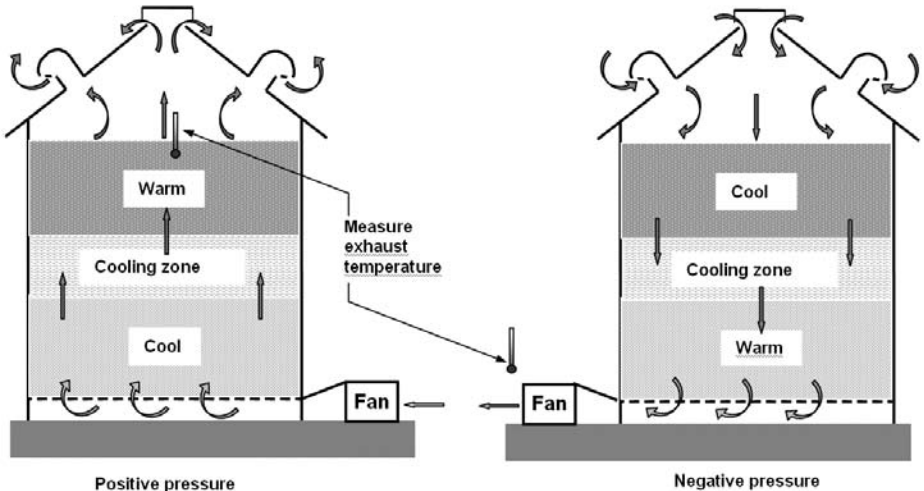
Figure 2.5 Movement of cooling zones during grain aeration.
