Northland Arboretum – Paul Bunyan Conservation Center: Rain garden

Eleanor Burkett, U of MN Extension, (888)241-0720, burke044@umn.edu

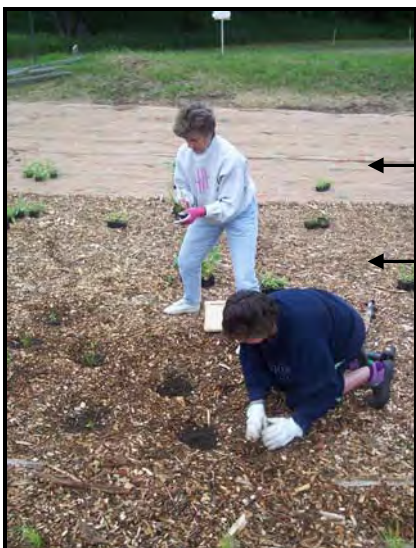
Planting

Hillside berm with erosion control blanket

Level bottom with wood mulch

The predominant soil type at this site is sand/gravel. Plant survival during drought periods was a concern due to the poor moisture holding capacity of the soil. The rain garden was over-dug and 2 inches of top soil and 2 inches of compost were tilled into the top 12 inches of parent soil. After the rain garden was dug and the berms constructed, coco fiber erosion control blanket was fitted over the berms and on the hillside slope (to prevent erosion).

The base of the rain garden was covered with 2" of wood mulch (to aid in moisture retention). Then 760 plants were planted. Cost for plants and materials (erosion control blanket and stakes) were approximately \$1,200.00. Wood mulch was provided by the arboretum.

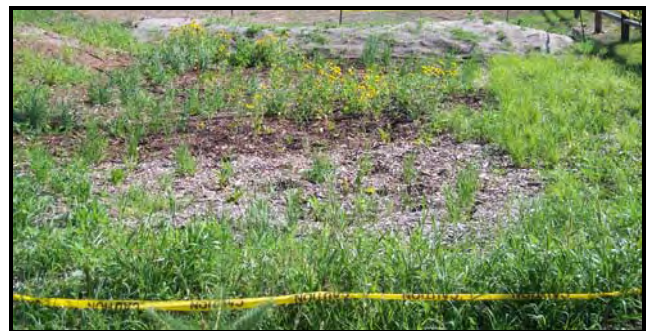
Two months after planting
